## CONSTRUCTION OBSERVATION REPORT #8

**Date:** October 11, 2016

**Project Title:** Arizona Way Bridge Construction Project

**Project #:** PW 2016-100

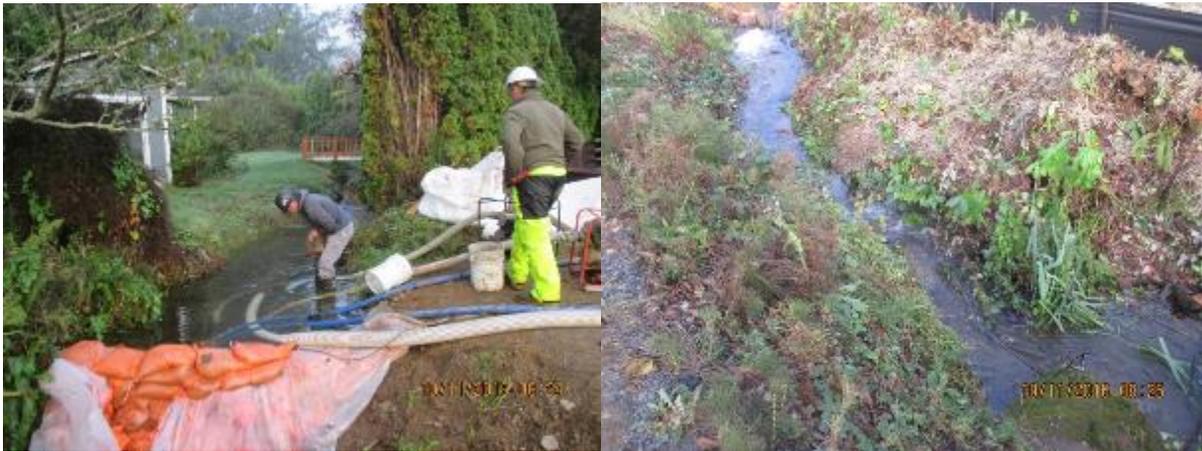
Stream turbidity comparisons at compliance locations

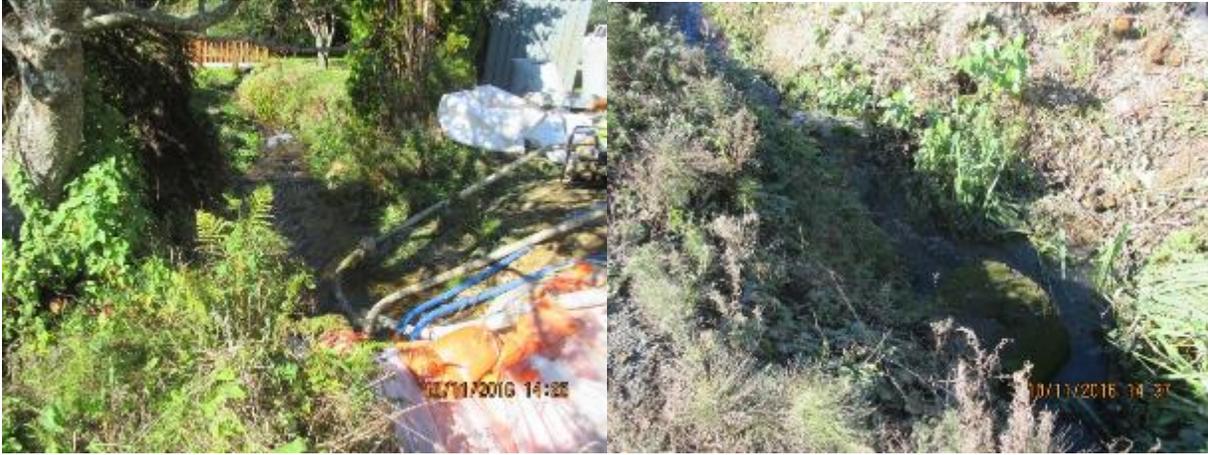
Stream turbidity comparisons at compliance locations
