## CONSTRUCTION OBSERVATION REPORT #8

**Date:** October 11, 2016

**Project Title:** Arizona Way Bridge Construction Project

**Project #:** PW 2016-100

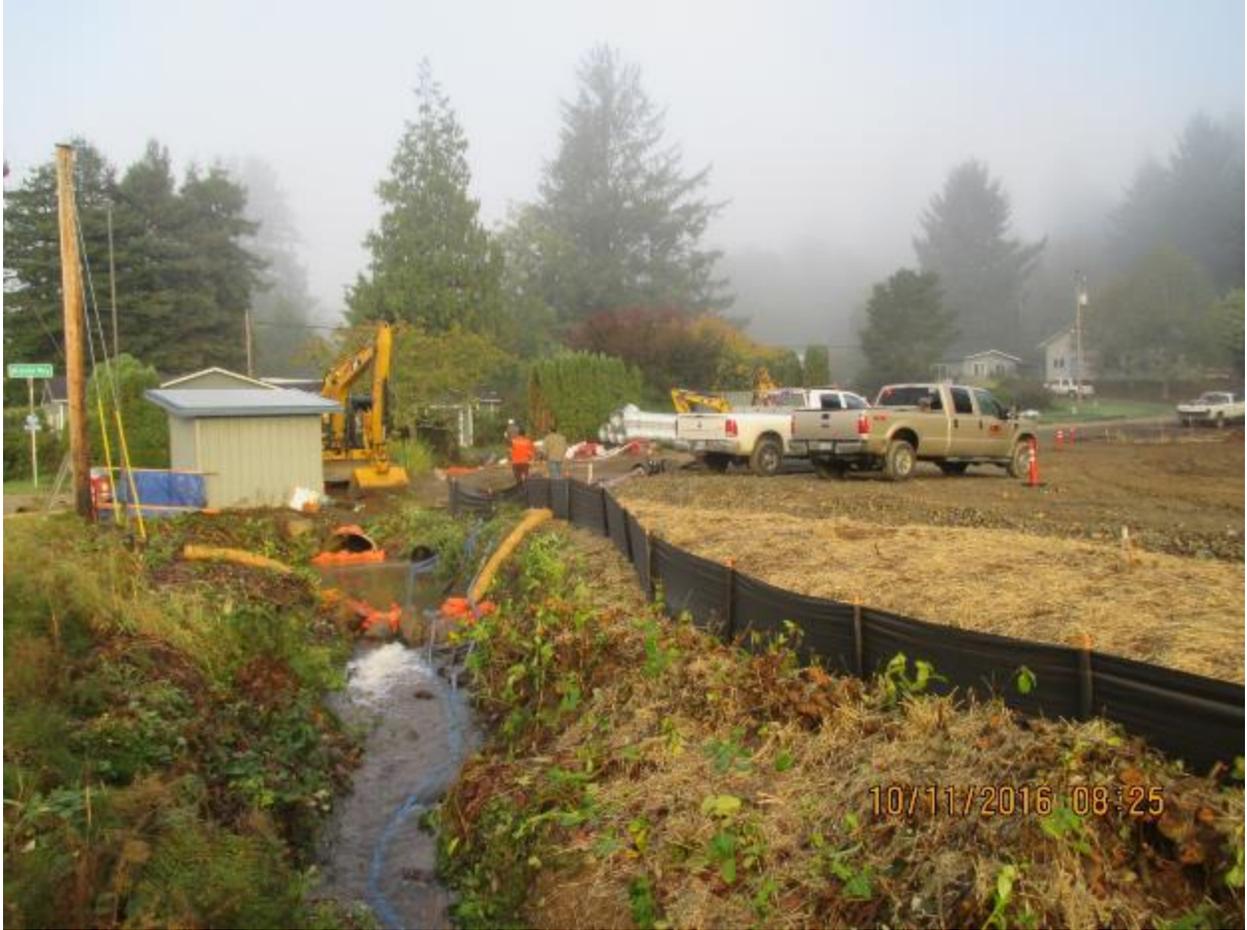
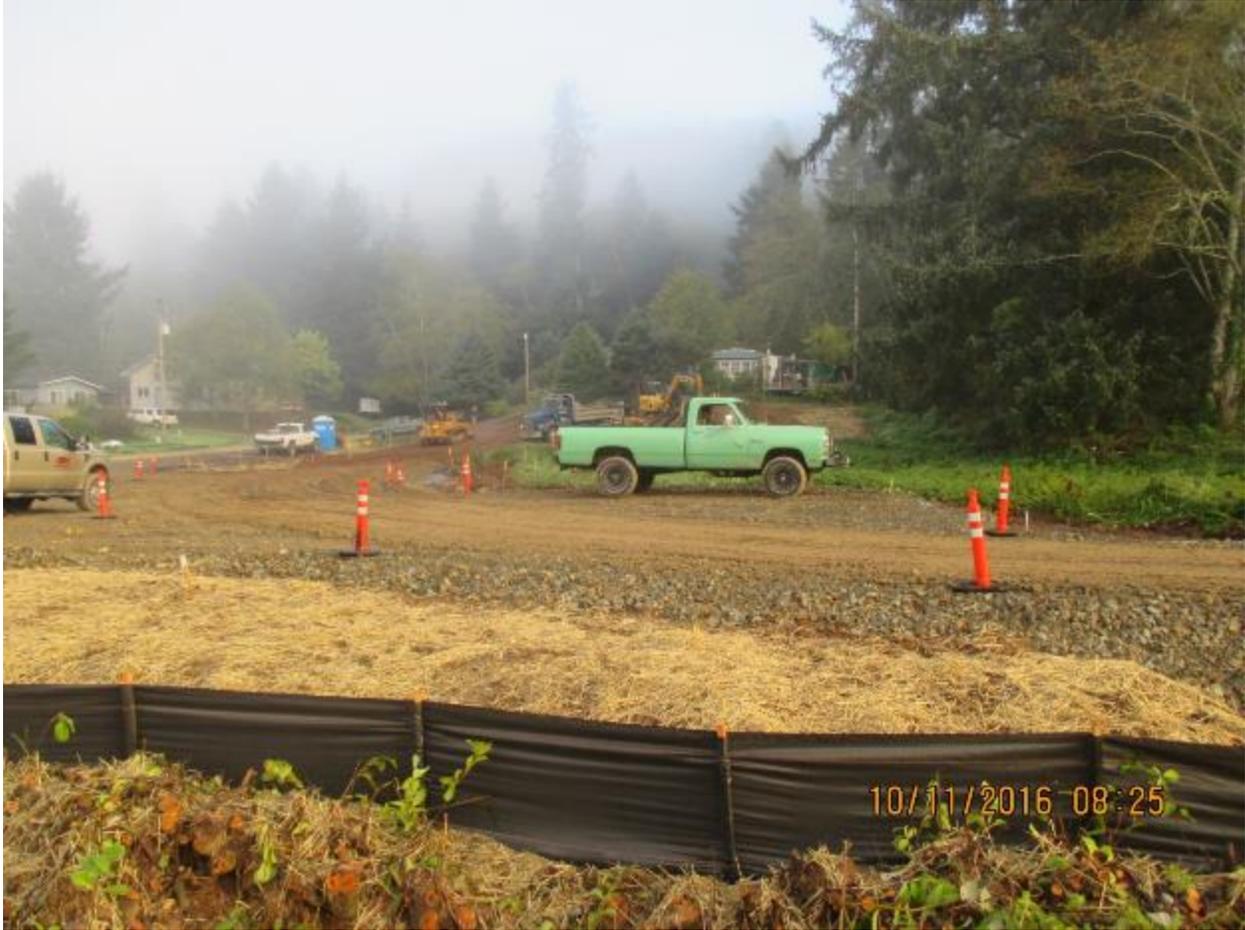
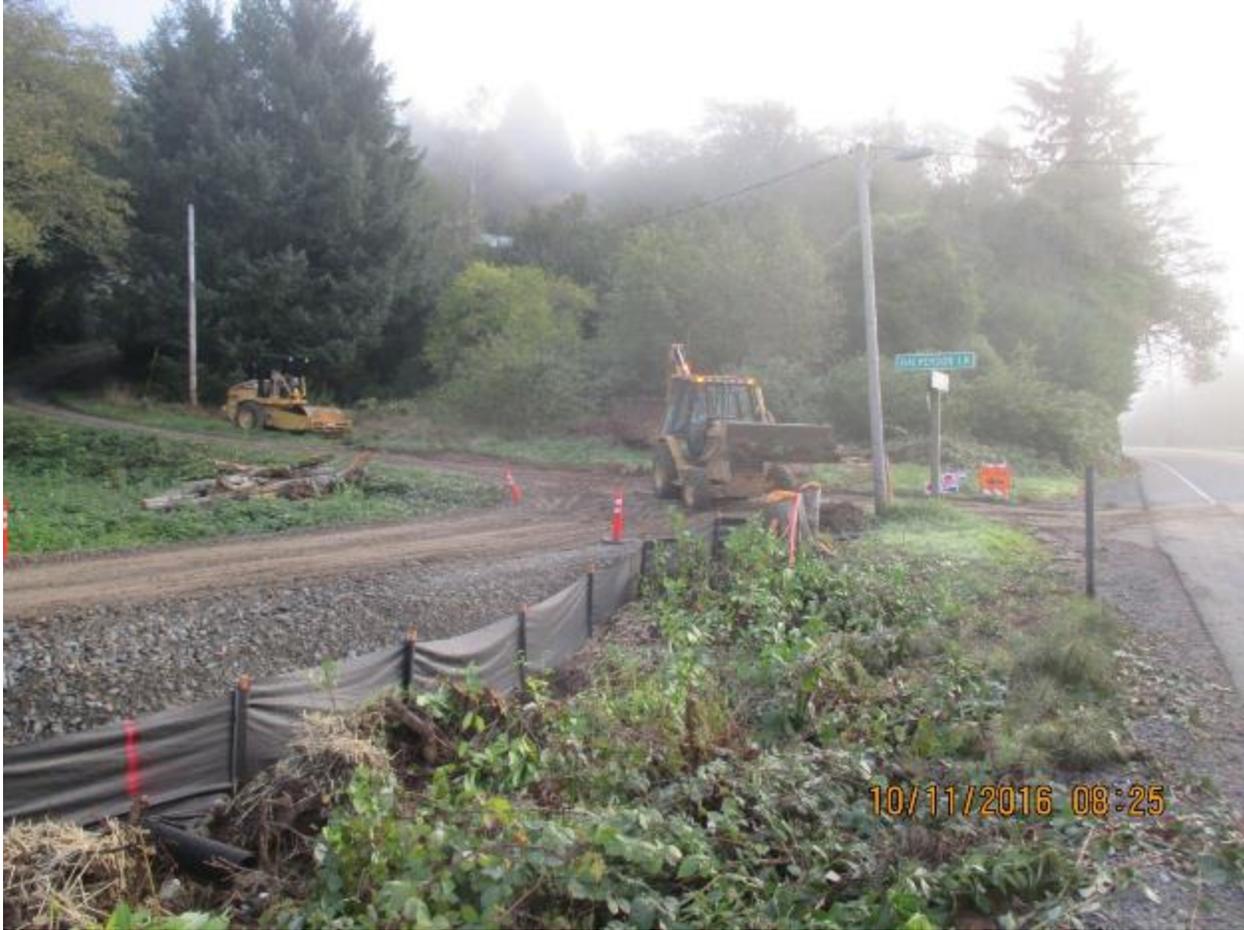
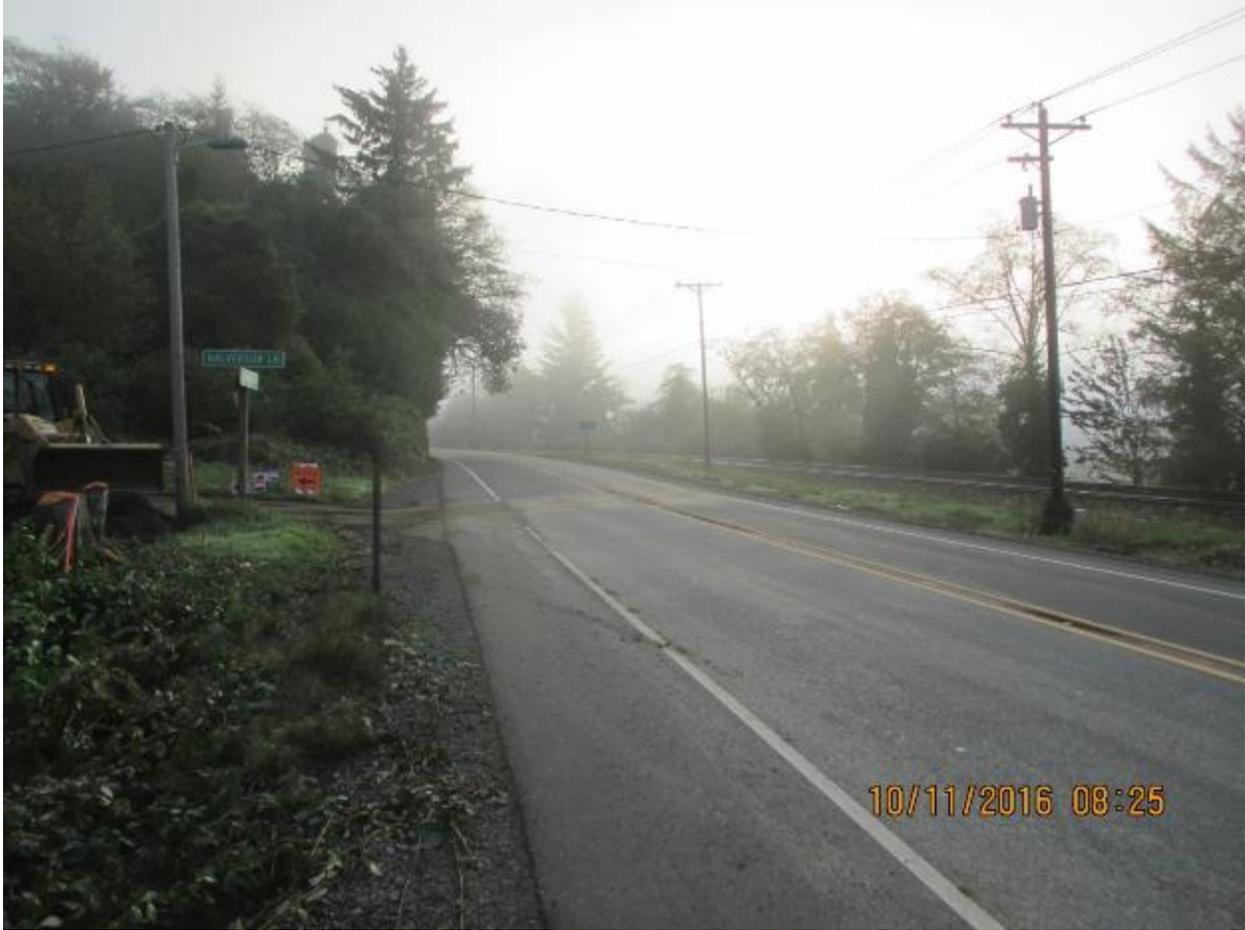
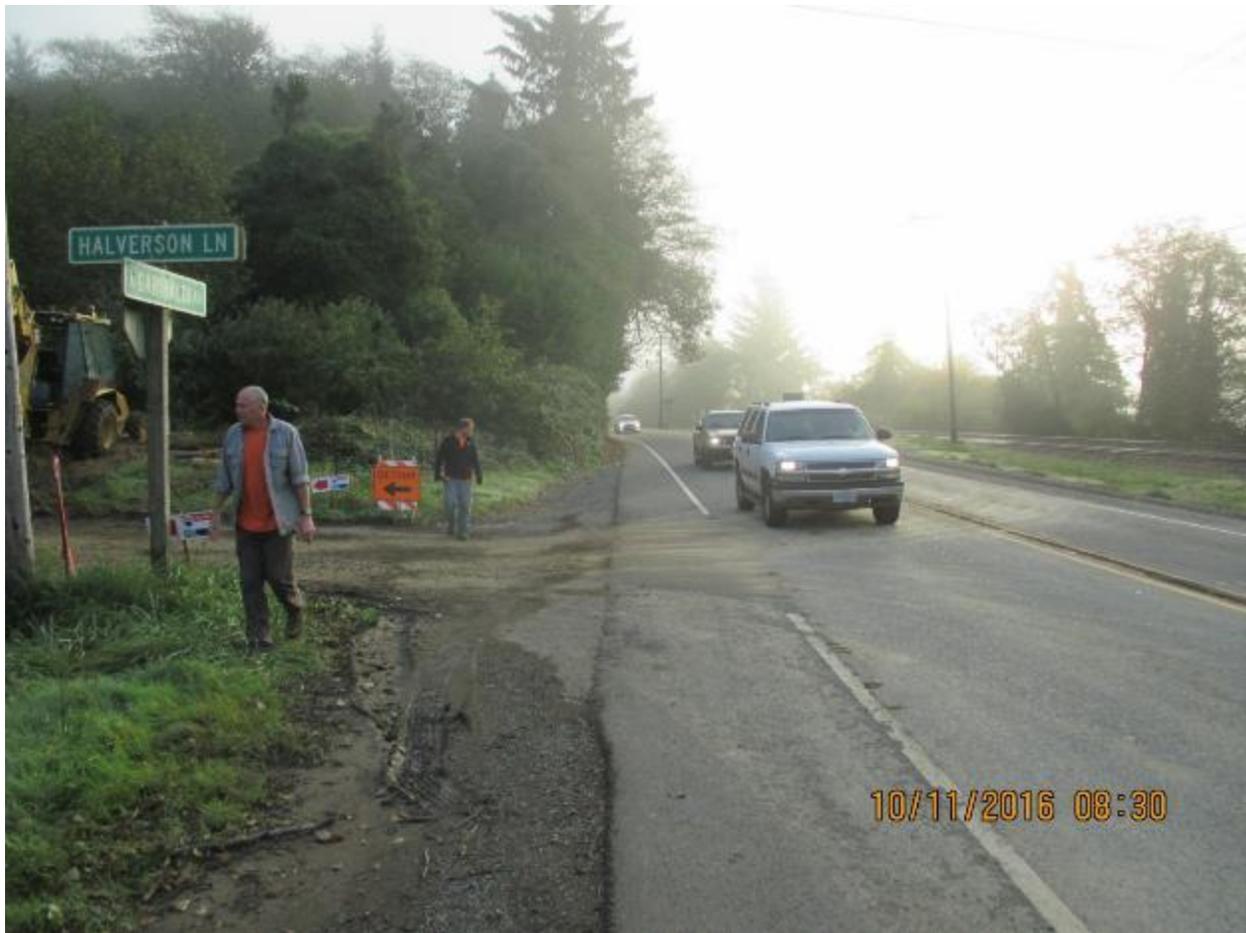
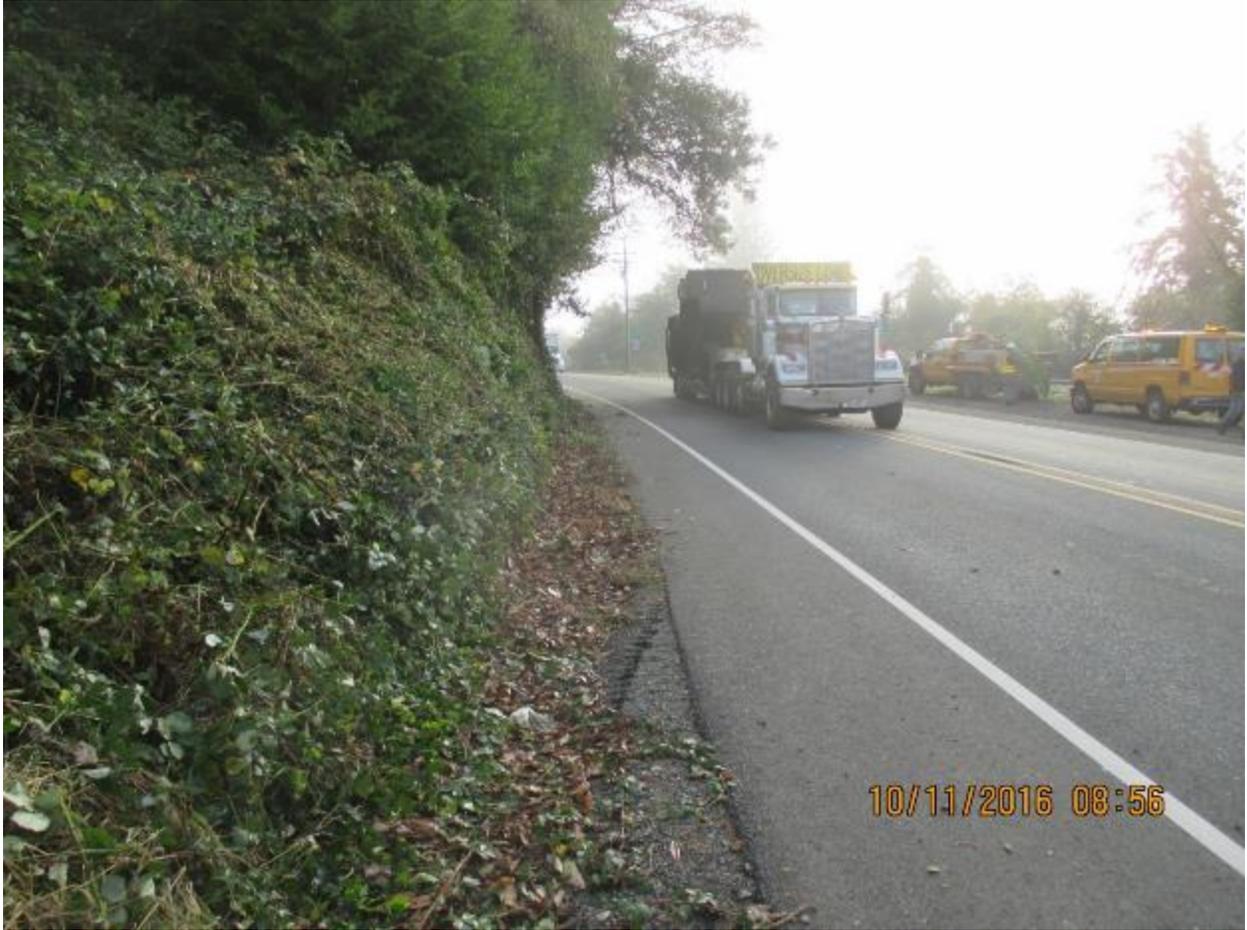
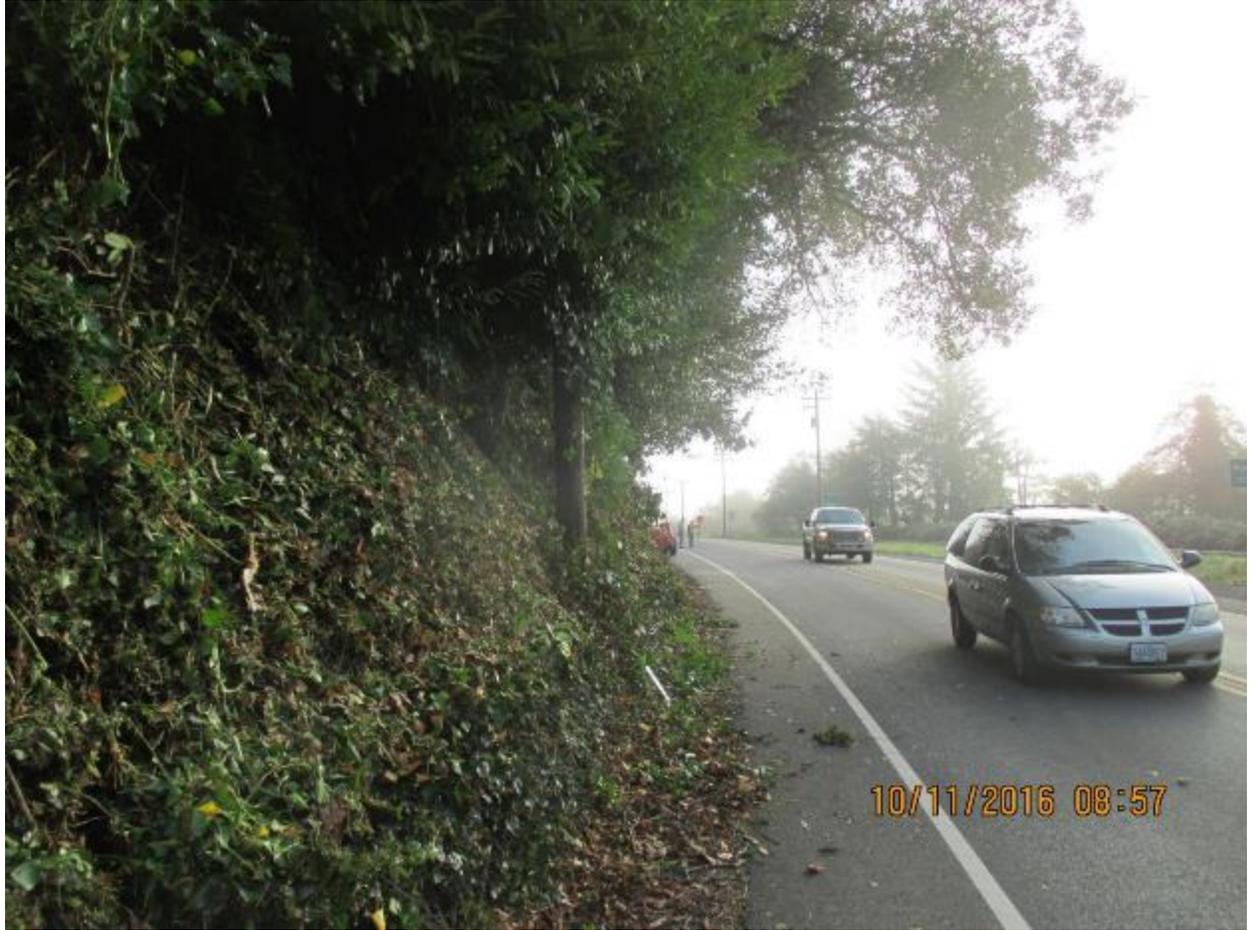
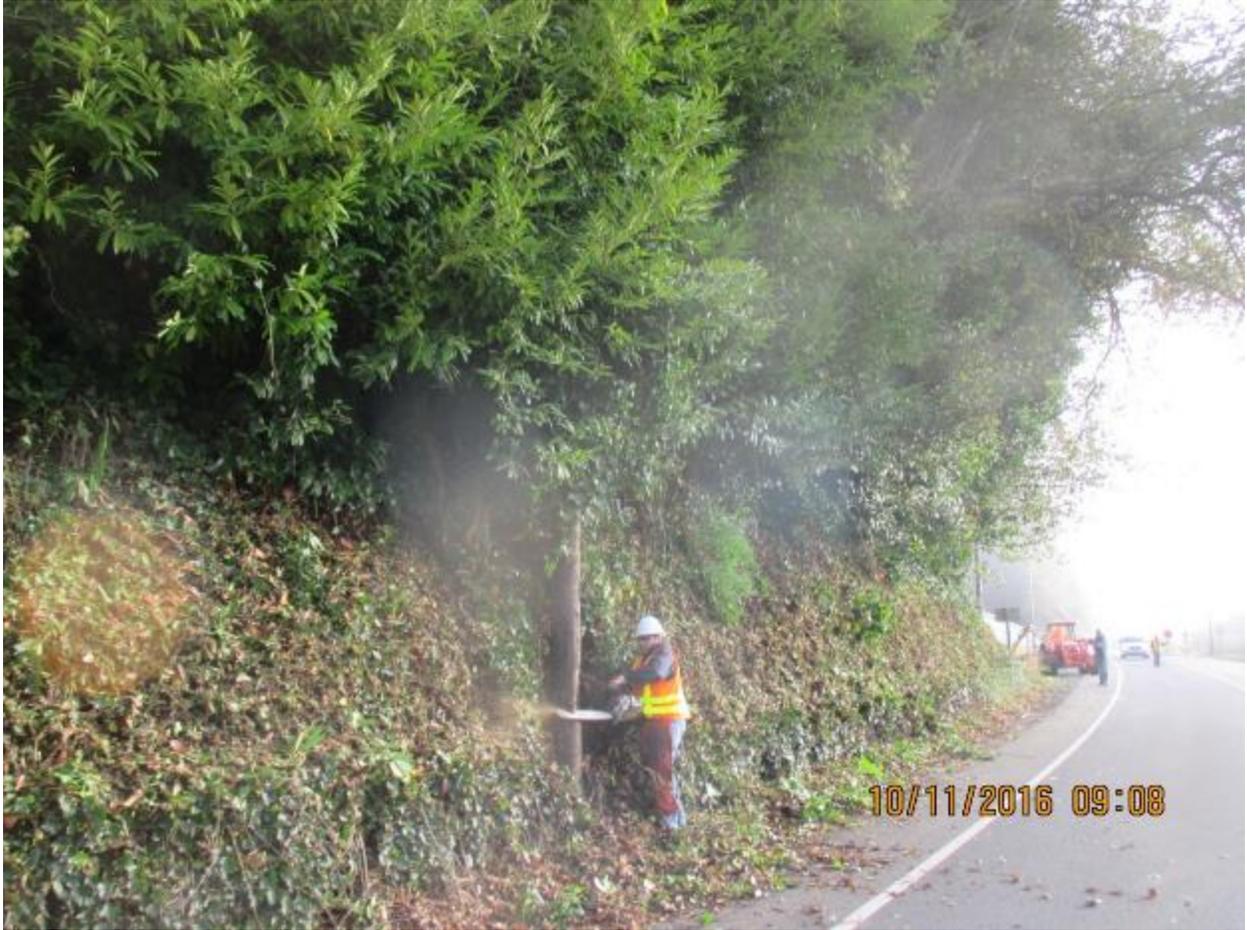
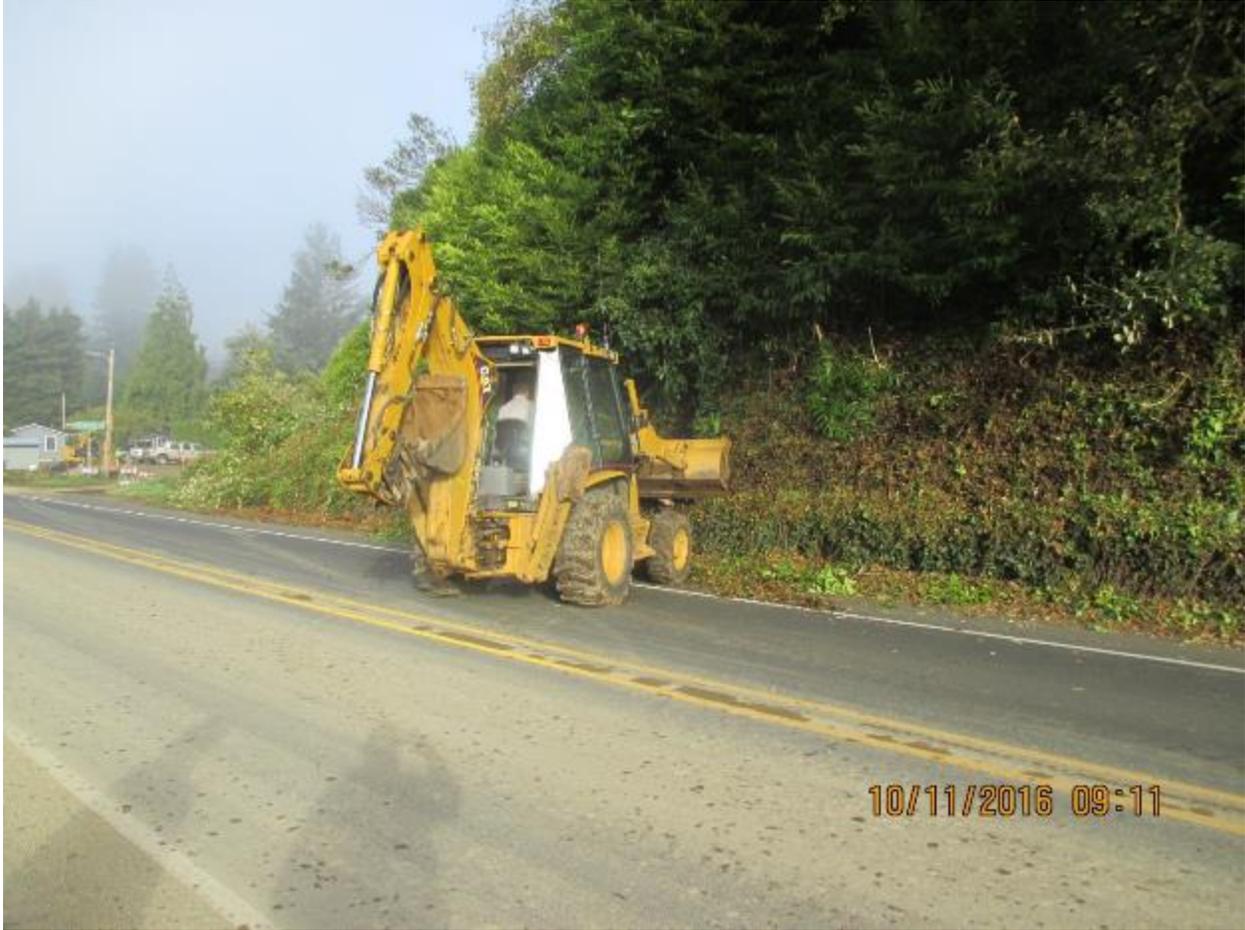
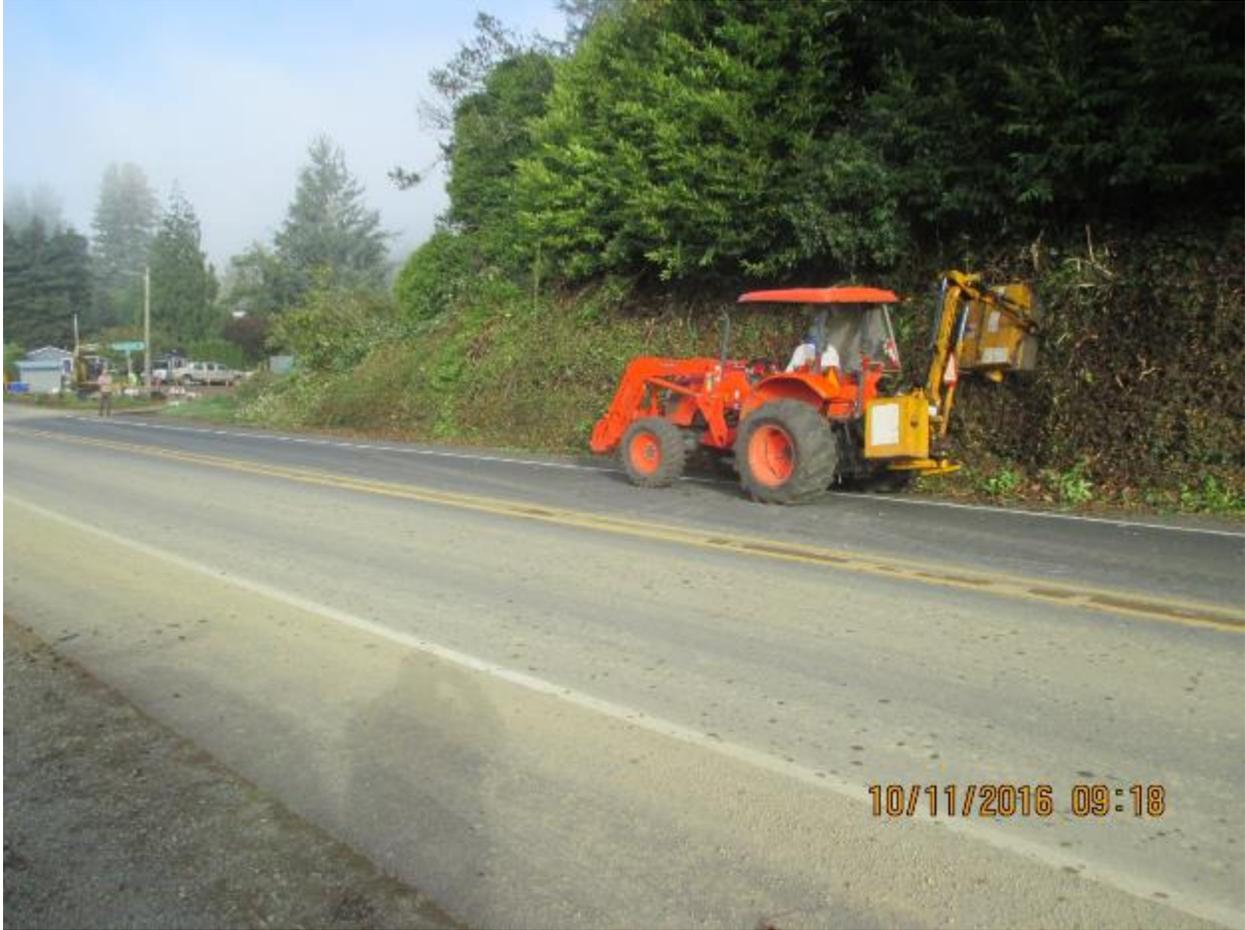
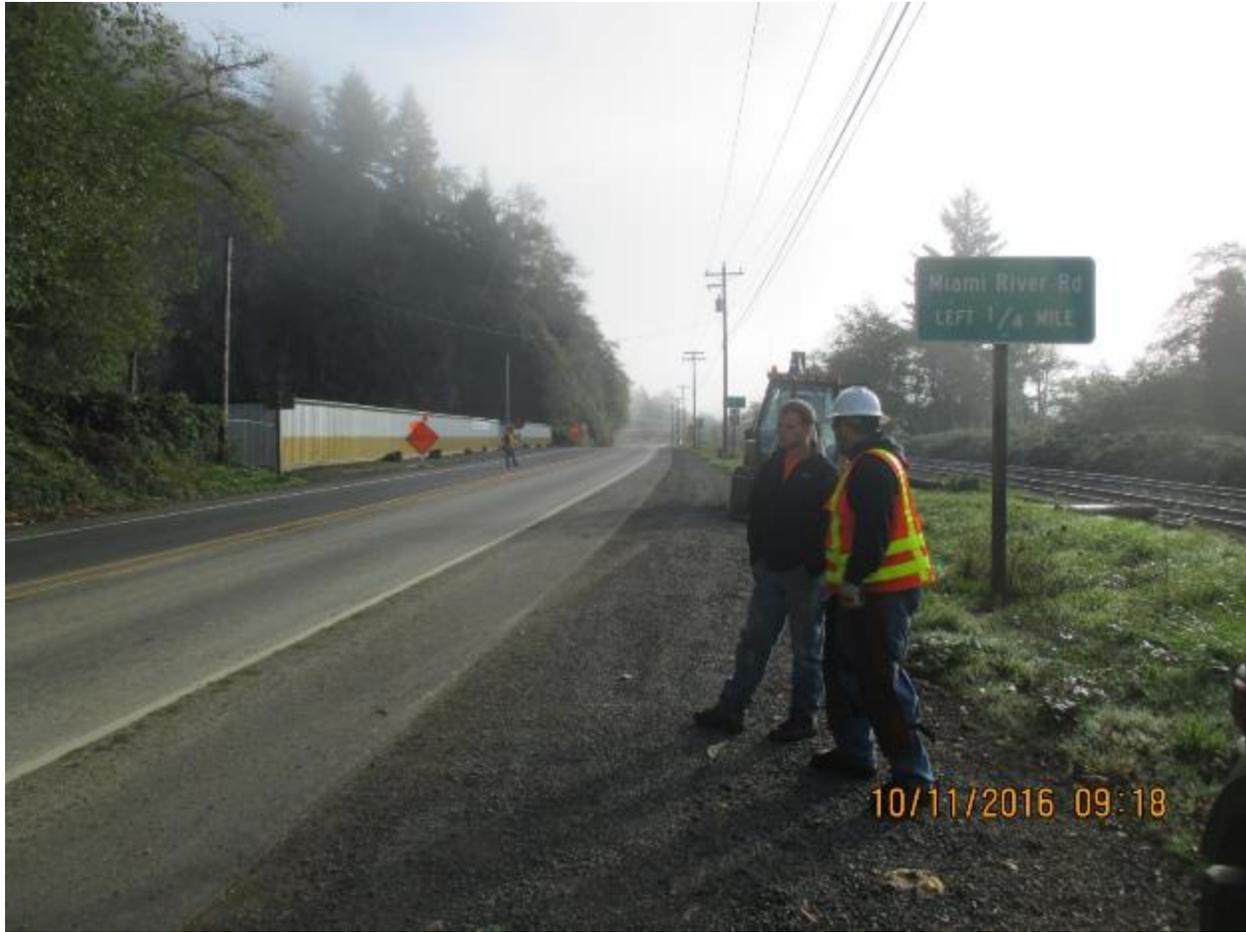
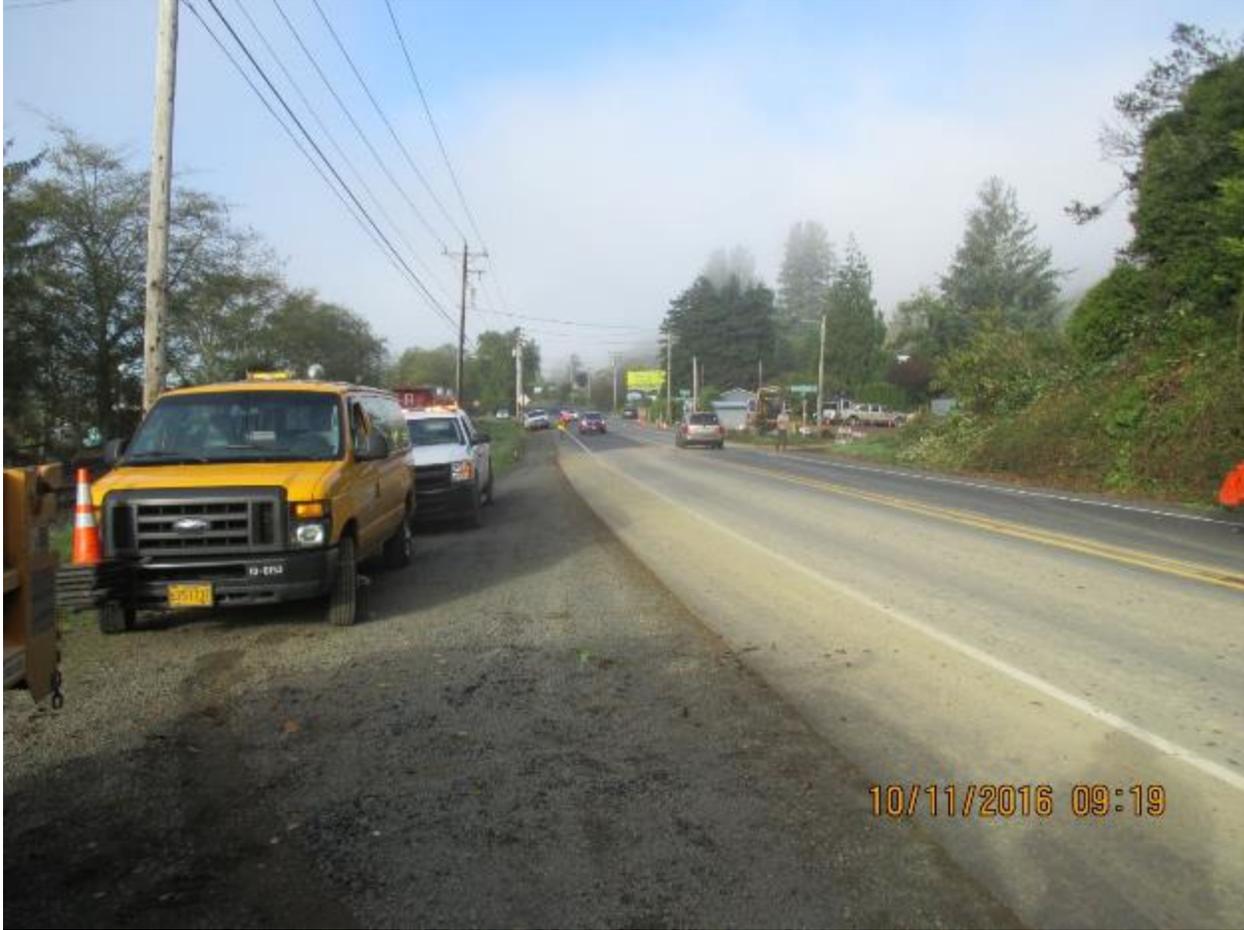
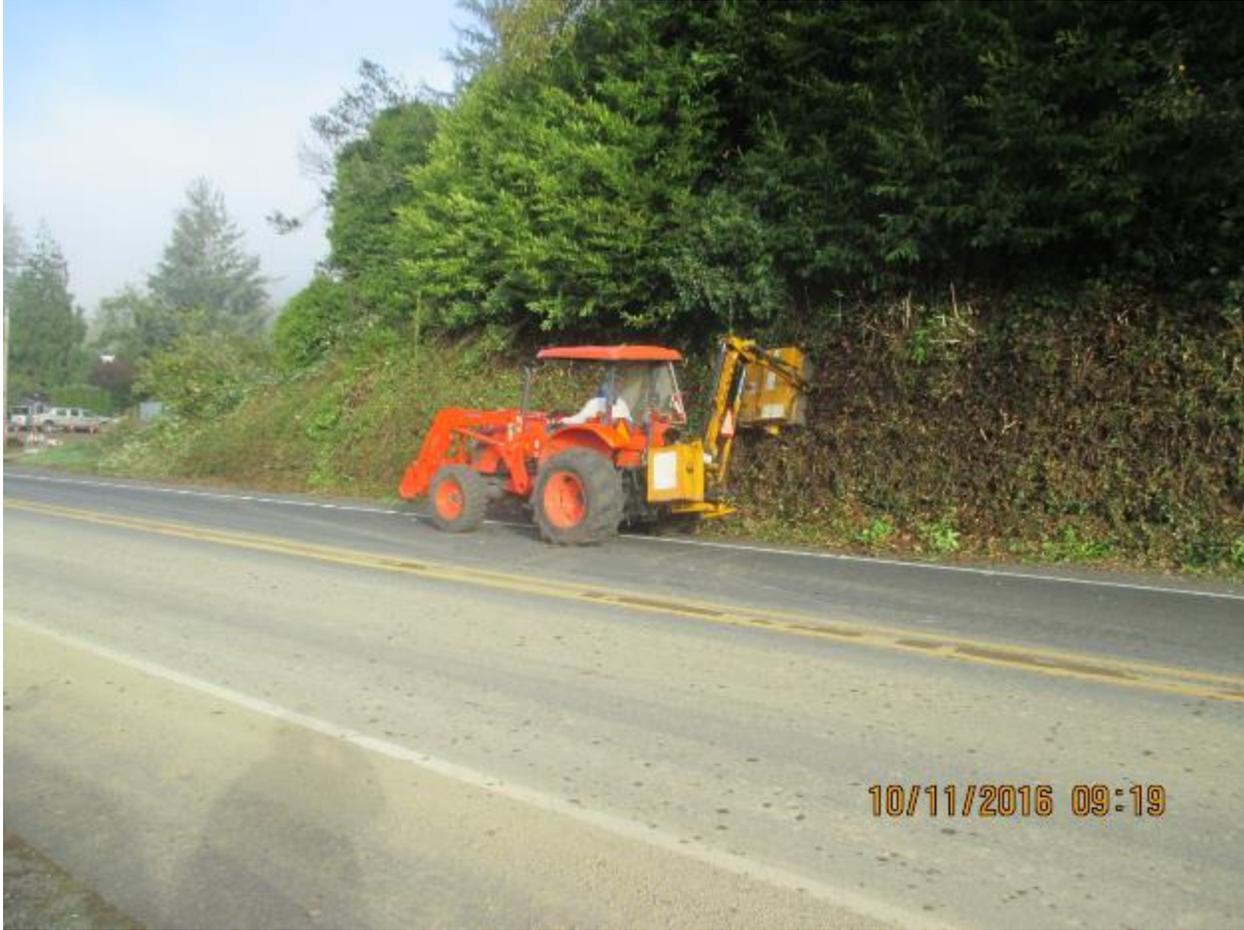
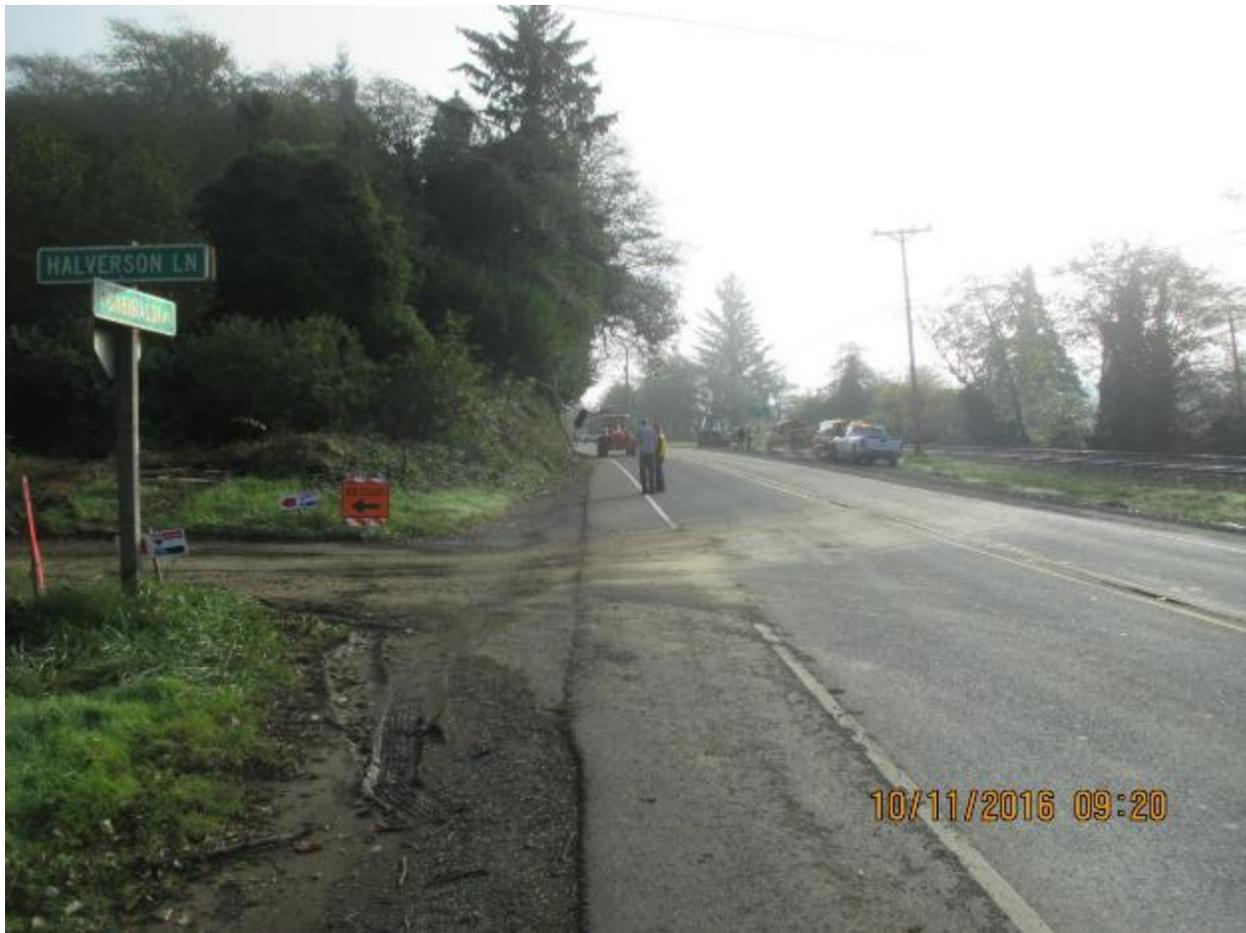
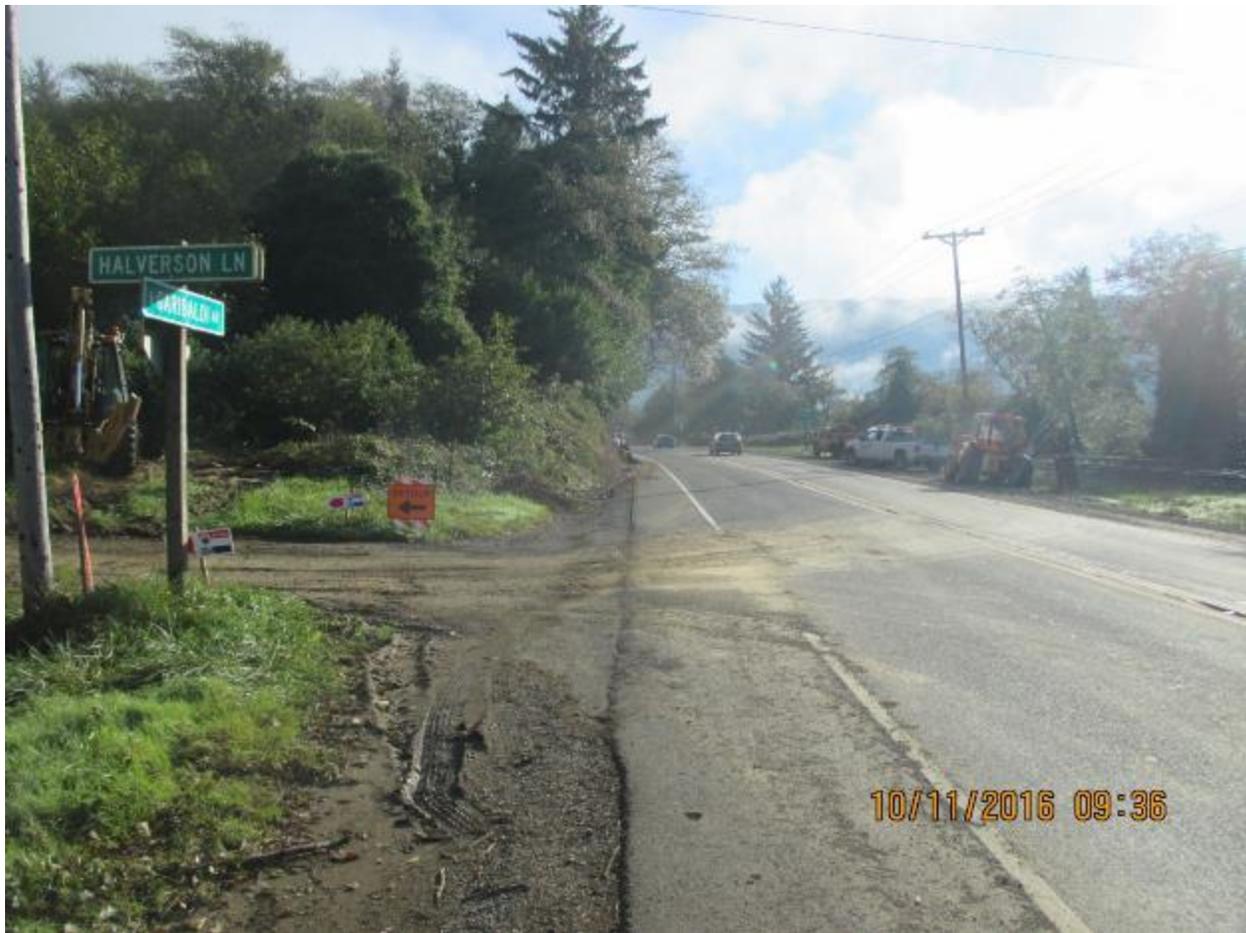
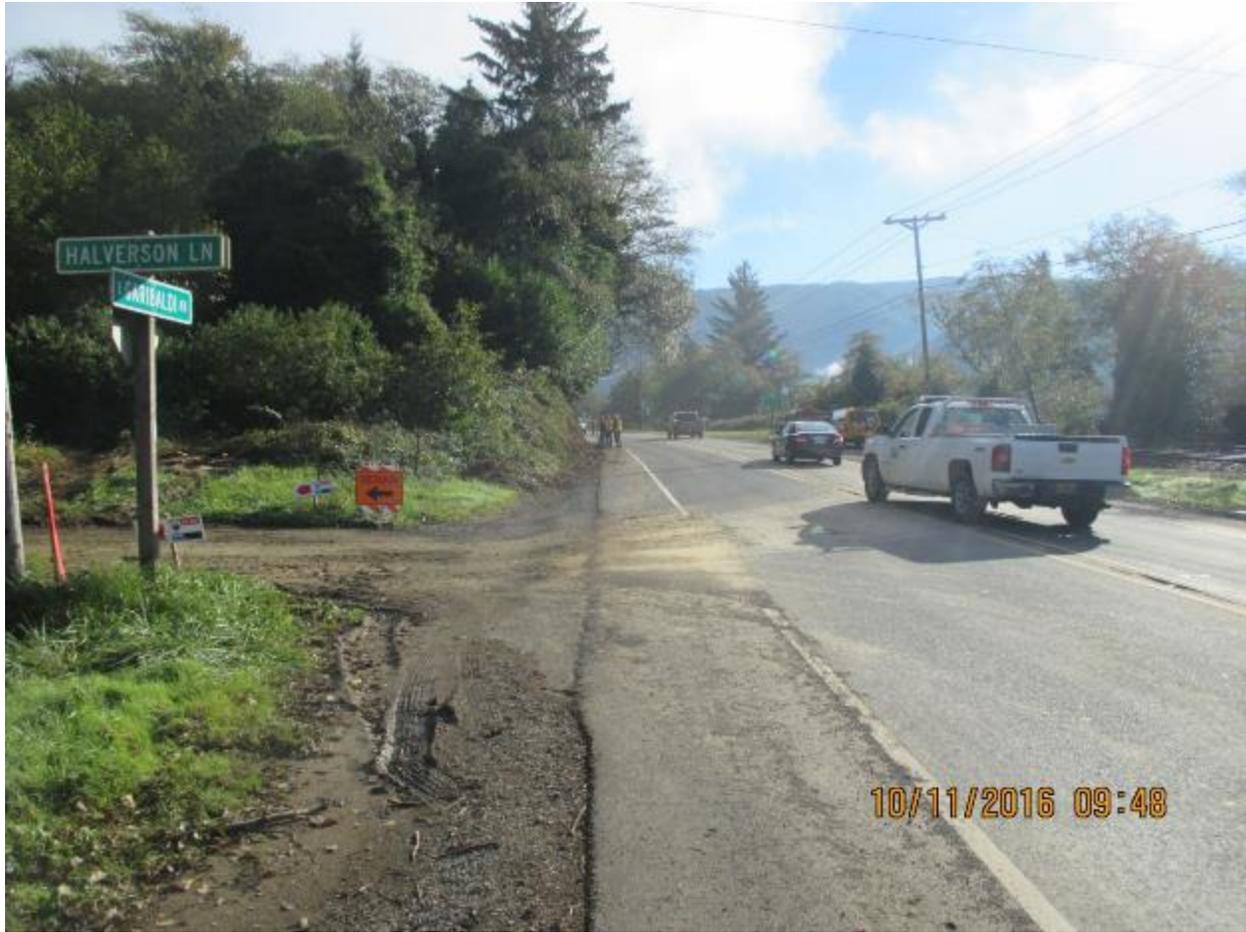
Contractor is pumping creek around existing culvert and preparing to install bypass culvert. ODOT is flagging on Hwy 101 so public works staff and equipment can clear brush to improve temporary access' sight distance. When taking out the existing culvert the water inside the culvert was turbid from the excavator digging it up and it released a plume downstream in the creek. Corrective measure applied was finishing removing the culvert quickly. The stream then quickly cleared and stream turbidity monitoring yields the same visual turbidity (clear) at both compliance locations. Temporary stream dams, straw mulch, silt fencing, vegetative buffer and rock covered work areas are controls and practices implemented at the start of the work.

Contractor broke the existing sanitary main serving 7-8 residences who must have been at work because there was no flow. Contractor quickly repaired the main. See photos below.
